**Real Estate Inspectors Inc.
954-567-3636**

**Inspection Report for:
1234 NE 15th Street, Any Town, FL 33011**

Prepared for: John Doe
Inspected August XX, 20XX at 1:00 PM

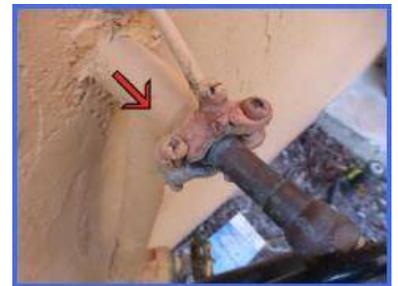
The ground wire was loose at the water pipe clamp at time of inspection. We recommend that a licensed electrician be contacted to conduct the necessary repairs to ensure that the wiring is properly grounded.

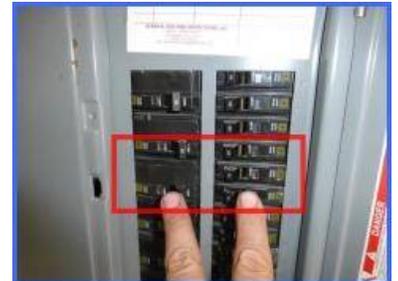
Condition of Wiring in Sub-Panel: A visual inspection of the wires in the electrical panel was done with the following items of concern:

There are 2 breakers within the sub-panel that were loose and arcing. We recommend that the affected breaker(s) be replaced by a licensed electrician with the proper manufacturer's breaker.

The price on the summary page is a "good faith" estimate for a licensed electrician to replace the affected breakers. We recommend further evaluation and repairs by a licensed electrician.

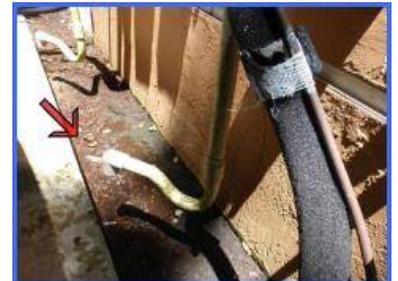
Condensation Line: **Although the condensation drain line or pump appears serviceable, the following items of concern were noted:**

The condensation line was dripping against the house - Consider having the condensation re-routed to a location that is acceptable.

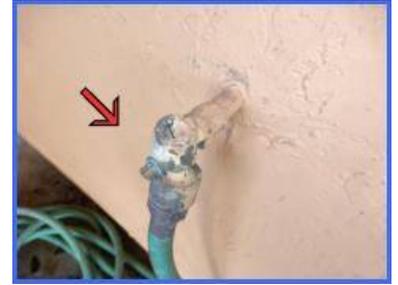
Missing/Broken handle noted at the following location - back patio. We recommend inquiring with current owner(s) regarding to the whereabouts of the handle. If the hose faucet handle is not located and re-installed - We recommend installation of a hose faucet handle to restore operation as intended.

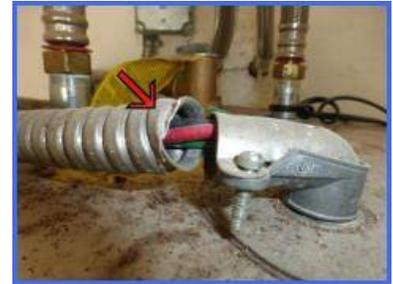
The electrical wiring for this hot water heater is provided through a flexible conduit, however the conduit is loose or damaged to the point that the wiring is exposed - if not rectified, damage to the electrical wiring can occur. We recommend that all exposed wiring be properly protected by a licensed electrician.

Cost on the summary page is to repair the conduit only. We recommend further evaluation and repairs by a licensed electrician.

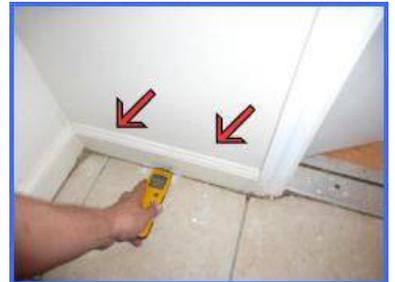
There were moisture at the baseboards around the front door - A check with a moisture meter indicated an elevated level of moisture, when tested at time of inspection. We recommend that the source of the water intrusion be identified and repaired to stop the leak. Once the water intrusion is taken care of, the affected areas need to be repaired/patch or otherwise brought to a condition that is deemed useful. It should be noted that the estimated price does not include any mold related restoration.

We recommend further evaluation and repairs by a

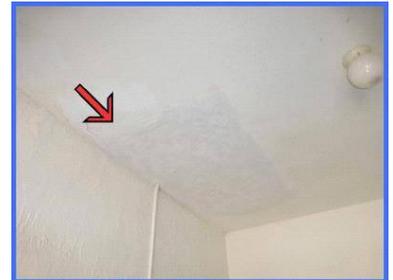
garage under bathroom

Water stains were noted at the garage and living room ceiling - The stains were checked with a moisture meter, which indicated within "normal" range, at time of inspection. It appears that this was a water leak that was not active the day of the inspection - We recommend periodic monitoring to make sure the leak was repaired properly.

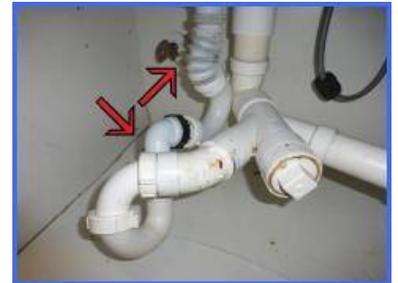
The trap at the drain line under the sink was not plumbed properly. We recommended having a plumber add a proper "P" trap under the sink.

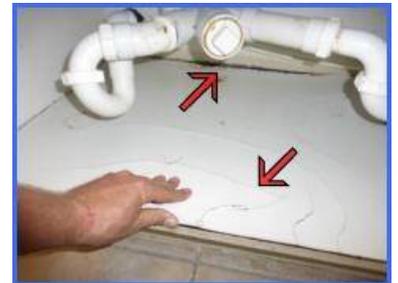
Water damage was noted to the kitchen sink cabinet most likely from a previous water leak. The bottom of the cabinet needs to be repaired with a new piece of wood. Further investigation is needed to see if there is any hidden damage or mold. Cost is to fix the damaged wood only. We recommend further evaluation and repairs by a licensed tradesman.

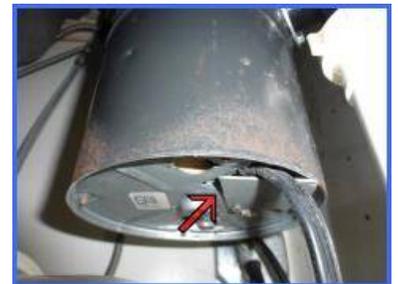
The power cord for the disposal was not installed properly and is being pinched. - We recommend that a bushing be re-installed to prevent damage to the power cord..

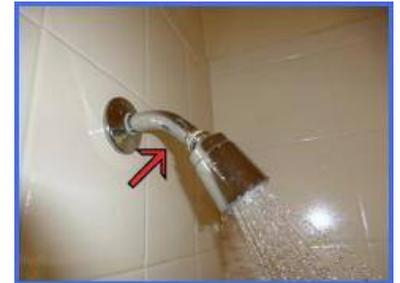
The shower head leaked or did not spray properly. Water either leaks from around the shower head connection or the shower head sprays in unusual patterns so that water could damage walls or ceilings. This can be caused by loose or cracked connections, damaged shower head, or mineral accumulation. We recommend repair or replacement of the shower head.

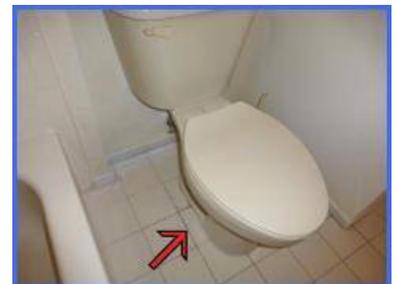
b. Toilet was not secure at floor. Typically is caused by loose bolts or a damaged flange. Other causes are possible. Loose toilets can cause leaks, water damage, and biological growth, as well as damage to the bolts or toilet or flange. Recommend further evaluation and repair by a licensed plumbing professional.
