**Real Estate Inspectors Inc.
954-567-3636**

**Inspection Report for:
1234 NE 15th Street, Any Town, FL 33011**

Prepared for: John Doe
Inspected August XX, 20XX at 1:00 PM

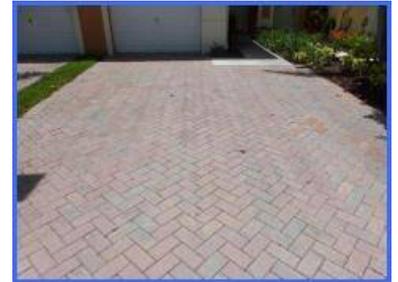
Driveway - Condition:

Overall, the driveway surface material is satisfactory with typical settling noted - none are significant.

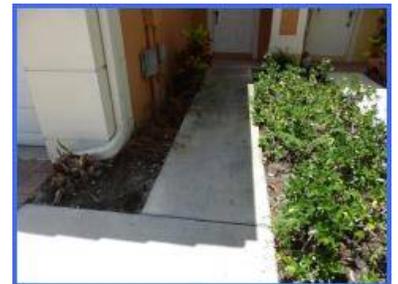
Walkway - Condition:

Overall, the walkway surface material is satisfactory with typical settling noted - none are significant.

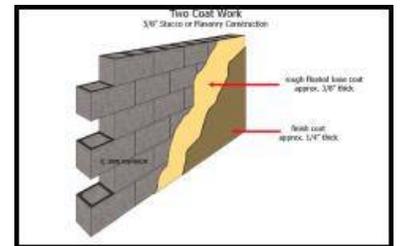
Condition of Exterior Walls & Siding:

Exterior wall siding material(s) were visually inspected and appear t be in good condition, with minor settlement cracks - none are significant.

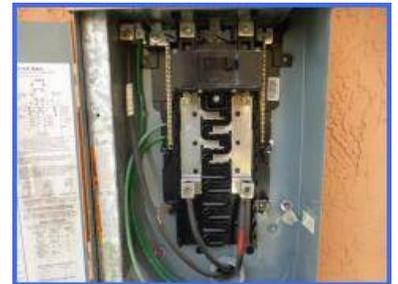
Main Service Ground Verified:

The ground wire was loose at the water pipe clamp at time of inspection. We recommend that a licensed electrician be contacted to conduct the necessary repairs to ensure that the wiring is properly grounded.

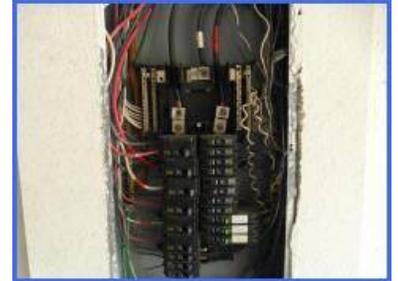
Condition of Wiring in Sub-Panel: A visual inspection of the wires in the electrical panel was done with the following items of concern:

There are 2 breakers within the sub-panel that were loose and arcing. We recommend that the affected breaker(s) be replaced by a licensed electrician with the proper manufacturer's breaker.

The price on the summary page is a "good faith" estimate for a licensed electrician to replace the affected breakers. We recommend further evaluation and repairs by a licensed electrician.

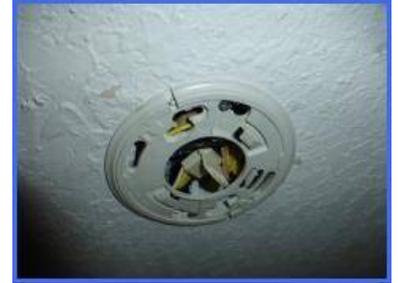
Smoke Detectors

Some smoke detectors are missing - We recommend replacing the missing smoke detectors.

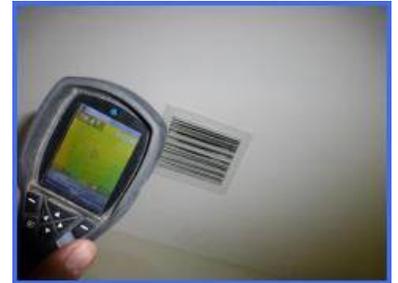
Temperature at Supply Registers: 78 F.

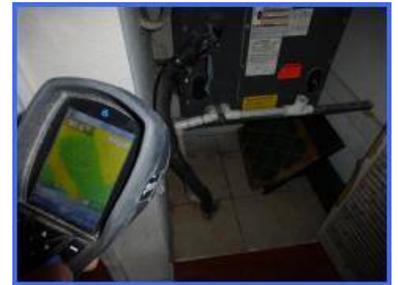
Temperature Differential:

The desired temperature differential across the evaporator is 15F - 25F degrees; however, the temperature differential across the evaporator did not drop at all. We recommend further evaluation and repairs by a licensed A/C repair person.

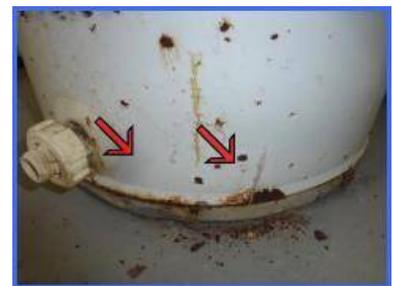
Exposed Water Heater Condition:

The water heater has deteriorated due to advanced rusting and leaks - We recommend replacing the water heater before the tank completely fails.

We recommend replacement by a licensed plumber.

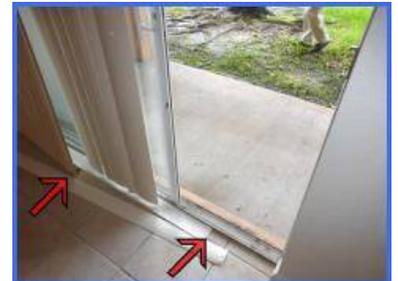
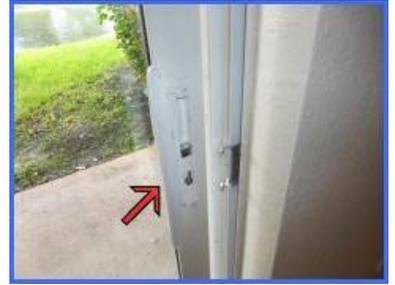
a. Sliding Glass Door (to/from living room): The rollers for this sliding glass door need adjustment, to include replacement (*if needed*) to operate as intended. We recommend having a reputable handyman or someone of the like to conduct the necessary maintenance to restore operation as intended.

b. Sliding Glass Door (to/from living room): The locking mechanism for this exterior door was damaged to a degree that is was not locking properly - We recommend having a reputable handyman or someone of the like to conduct the necessary repairs, to include replacement to restore operation as intended.

We recommend further evaluation and repairs by a licensed tradesman.

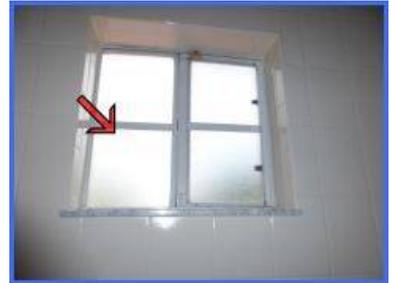
a. Horizontal Sliding Type (guest bathroom):

The rollers for this window need adjustment, to include replacement (*if needed*) to operate as intended. We recommend having a reputable window company or someone of the like to conduct the necessary maintenance to restore operation as intended.

We recommend further evaluation and repairs by a licensed tradesman.

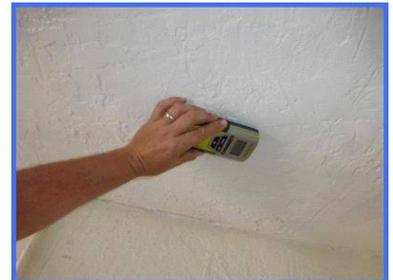
Water stains were noted at the garage and living room ceiling - The stains were checked with a moisture meter, which indicated within "normal" range, at time of inspection. It appears that this was a water leak that was not active the day of the inspection - We recommend periodic monitoring to make sure the leak was repaired properly.

garage under bathroom

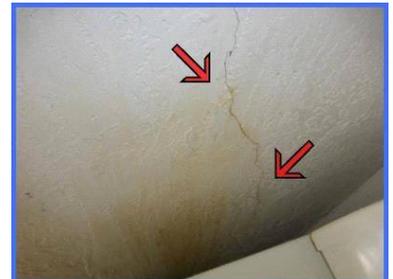
garage under bathroom

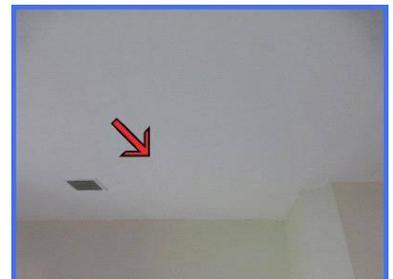
garage under bathroom

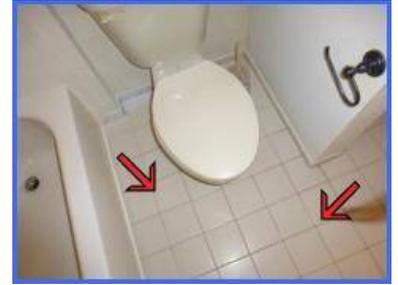
The flooring material for the guest bathroom has suffered water damage at some point in the past. The tiles are loose at the floor - We recommend that the floor tiles be replaced.

We recommend further evaluation and repairs by a licensed tradesman.

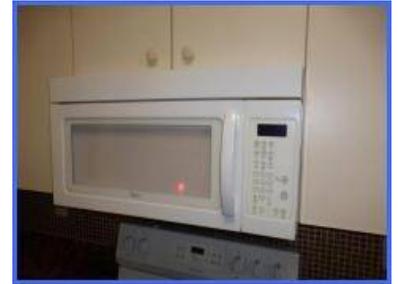
A minor crack by the door handle was noted.

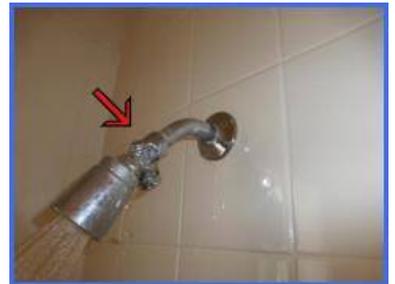
a. The shower valve over rotates past the stop or off position making easy to accidentally leave the water running when turning the tub off. We recommend repairs by a licensed plumber

b. The shower head leaked or did not spray properly. Water either leaks from around the shower head connection or the shower head sprays

in unusual patterns so that water could damage walls or ceilings. This can be caused by loose or cracked connections, damaged shower head, or mineral accumulation. We recommend repair or replacement of the shower head.

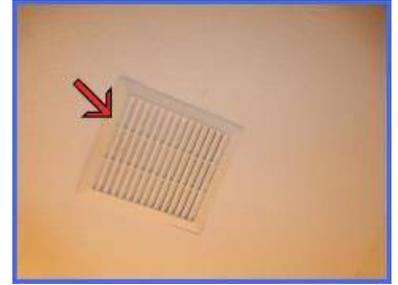
The exhaust fan failed to activate using "normal" controls - It's more likely than not the current owner(s) un-plugged the vent. Un-plugging the vent fan is typical when the fan motor is noisy. We recommend that the current owner(s) restore operation as intended - Once restored further evaluation can be gleaned.

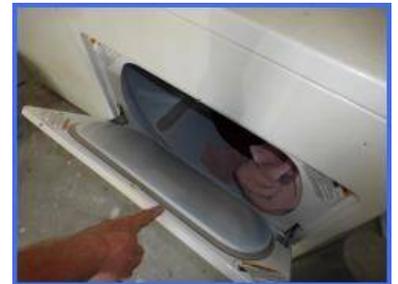
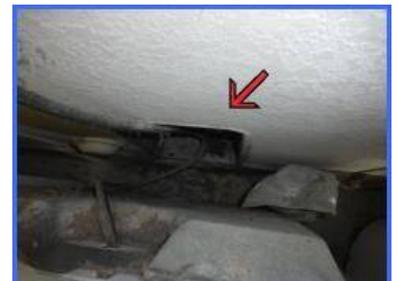
a. The dryer vent does not vent to the exterior - it ends prematurely or does not travel through to the exterior. We recommend that the vent tube be extended to route to the exterior of the structure.

b. The safety switch for the door of the clothes dryer is damaged. The unit doesn't turn off when opening the door. We recommend that the switch be repaired to restore operation as intended.
